Orbiter Assessment of STS-107 ET Bipod Insulation Ramp Impact

January 23, 2003

Order of Analysis

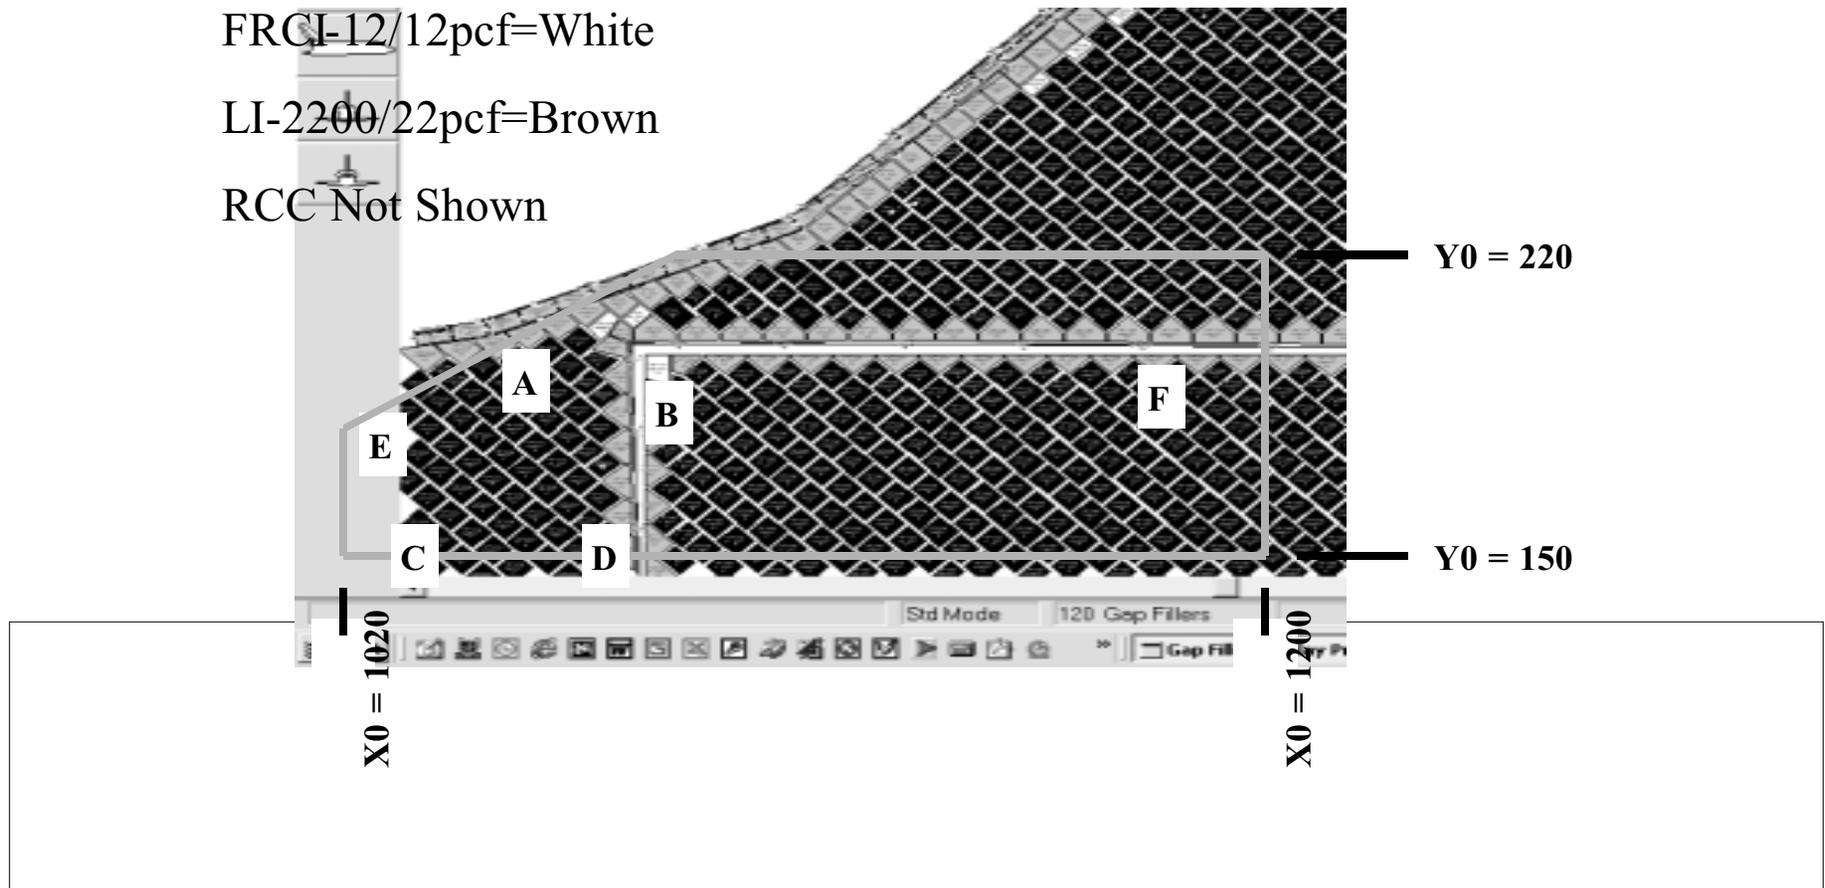
System Integration Inputs Were Matched Against Orbiter Tile/RCC to Determine Critical Locations

LI-900/9pcf=Black

FRGI-12/12pcf=White

LI-2200/22pcf=Brown

RCC Not Shown

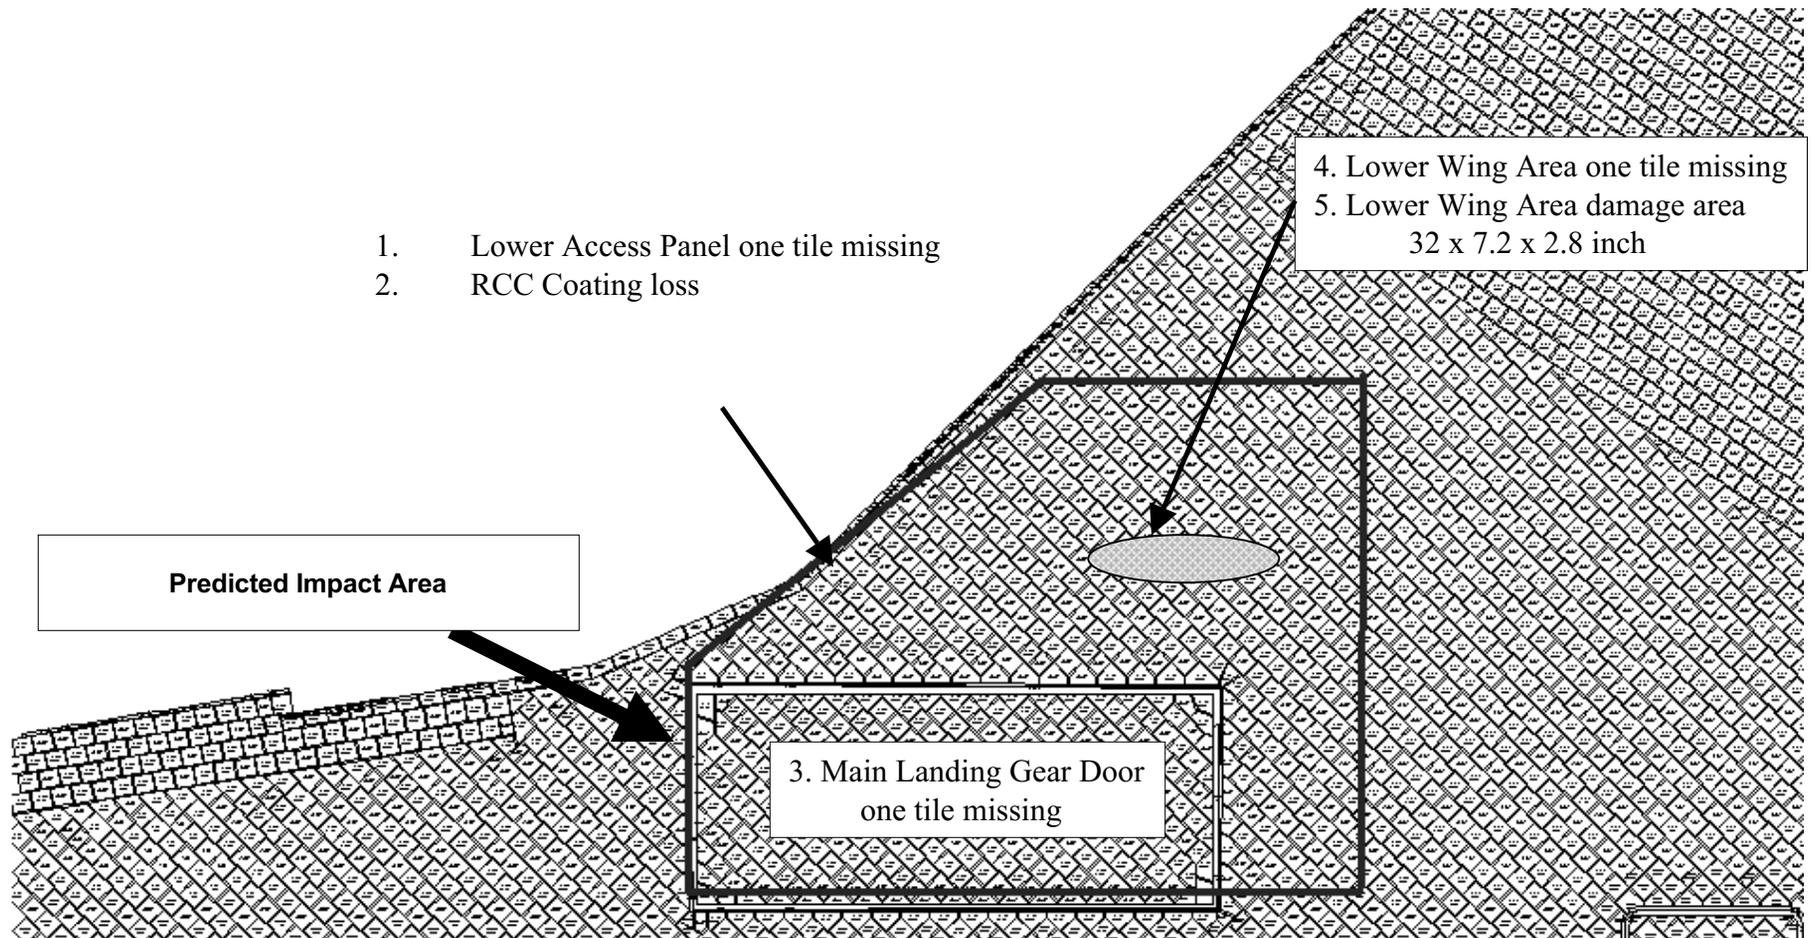
Thermal Analysis Assessment of Debris Impacted Lower Surface in STS-107 Mission Locations

Impacted Lower Surface Location Thermal Predictions

Case	Location	Assumptions	Results
1	Access Panel (one tile missing)	Loss to last layer of TMM Densified layer ~ .2 inches	Temperature of Al Tube Carrier 790 °F No issue
2	RCC Panel 9 Lower Flange OML (Coating Missing)	Coating loss and Carbon substrate exposed	Substrate thickness: 0.193 inches Loss .09 inches No issue
3	Main Landing Gear Door (one tile missing)	Loss to last 2 layers of TMM Densified layer ~ .4 inches	Temperature of Structure 540 °F No issue
4	Lower Wing Area (one tile missing)	Loss to last 2 layers of TMM Densified layer ~ .4 inches	Temperature below 350 °F design req. No issue
5	Lower Wing Area (32 x 7.2 x 2.8 inch) Damage	Loss to last layers of TMM Densified layer ~ .2 inches	
6	Main Landing Gear Door (several tiles Lost)	Loss to last layers of TMM Densified layer ~ .2 inches
